MERRIMACK RIVER BASIN  
FRAMINGHAM, MASSACHUSETTS

FOSS RESERVOIR DAM  
MA00339

PHASE I INSPECTION REPORT  
NATIONAL DAM INSPECTION PROGRAM

APRIL 1981

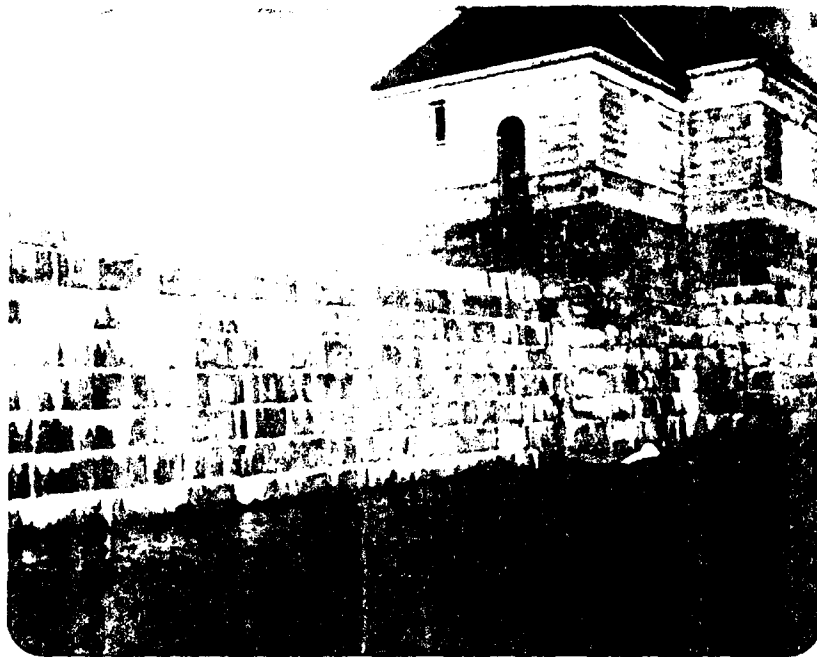
- c. Appurtenant Structures. The spillway is a narrow-crested, stone masonry weir without flashboards. The stone masonry was in good condition. Slight efflorescence and minor openings in the joints were visible on the downstream face of the weir (see Photo No. 9). However, no areas of leakage through the masonry were observed.

NO. 9 DOWNSTREAM FACE OF SPILLWAY

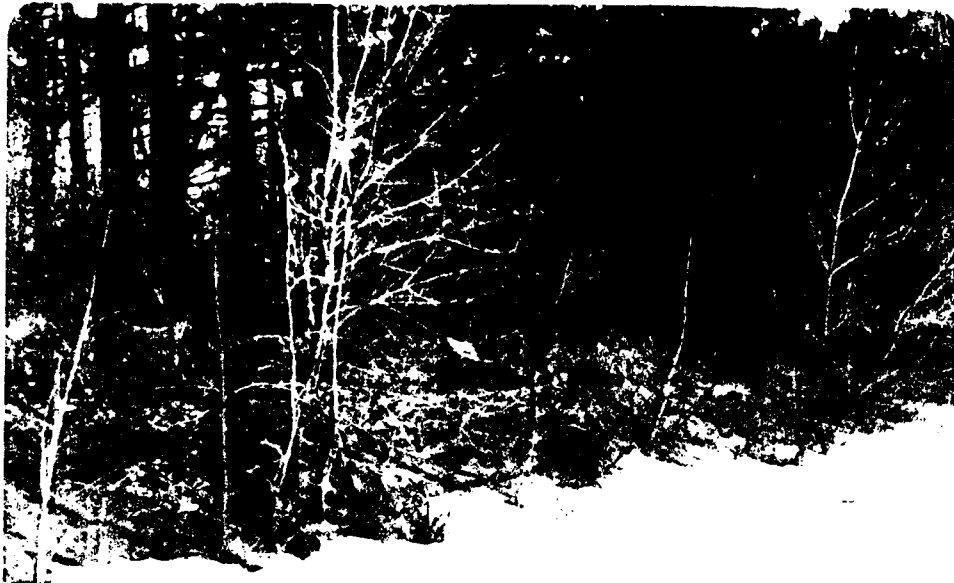
An earthfill dike is located about 1,000 feet north of the main dam. The upstream and downstream slopes are overgrown with brush and trees (see Photos 11 and 12). Riprap has been placed on the upstream slope. The top of the dike is relatively clear of vegetation, however, erosion has occurred due to tire ruts which exposed tree roots embedded in the embankment. There was no seepage observed at the downstream toe, but the dike was not impounding any water at the time of inspection.

NO. 11 UPSTREAM SLOPE OF DIKE

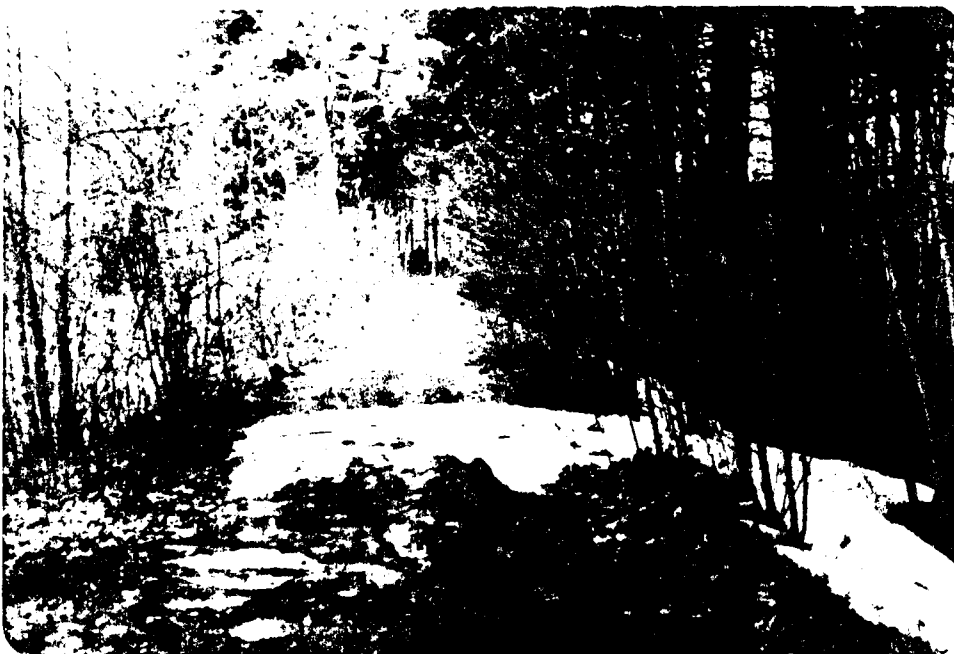
NO. 12 TOP OF DIKE
